May 9, 2017

PEA Project No: 2016-344

**RE: Bank Erosion Investigation
Raintree Village – Regional Retention Pond
City of Troy, Oakland County, Michigan**

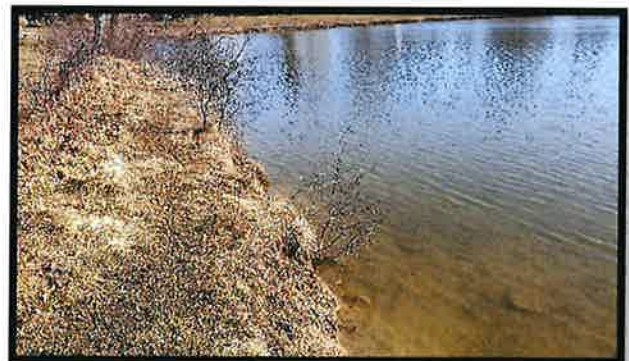
During our site visit, we observed the water level was approximately 0.75-feet below the normal water depth. We photographed the pond banks and observed minor long-term erosion at the toe-of-slope. There are areas where the pond banks have sloughed into the water and other areas where the pond bank has eroded due to long term wave action or seasonal water fluctuations. There was also

some evidence of rainwater runoff causing some surface erosion, and ducks/geese trampling the banks and eating the plants that secure the soil. As related to erosion, the only area of concern is at the inlet from the Shanahan Drain. The banks have eroded behind the wing walls. The slopes adjacent to the wing wall are nearly vertical and approximately 4-ft high above the water surface.

As previously mentioned, the erosion of the pond banks has occurred over 40-years with no preservation. The majority of the side-slopes are unvegetated and drop 1 to 2-feet off the edge and left untreated will continue to erode. At a minimum, the banks near the Shanahan Drain outlet and the headwall should be restored.

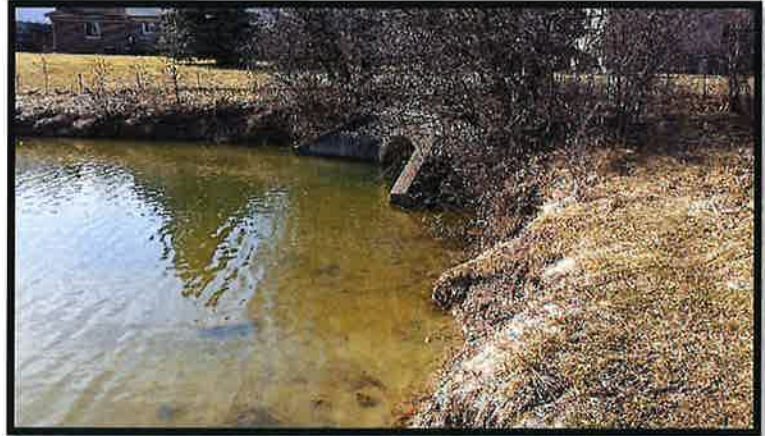
We also reviewed historical aerial photographs from 1999 to 2017 and compared them to the original design plans. It appears that the pond is essentially the same shape, but the banks have receded about 6-ft over the last 40-years.
